INSPECTION REPORT

123 West 456 South
Provo, Utah 84604
Prepared For: John Doe
Date: 4/9/2020 Time: 9:00 AM

Inspector: Mike Thomson
NACHI16060803

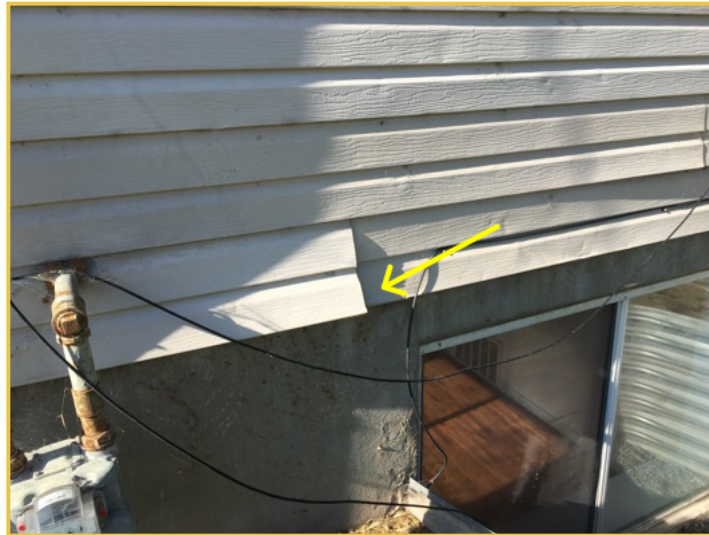
- Siding was loose, damaged, or had gaps. Recommend repair.

Damaged North Siding

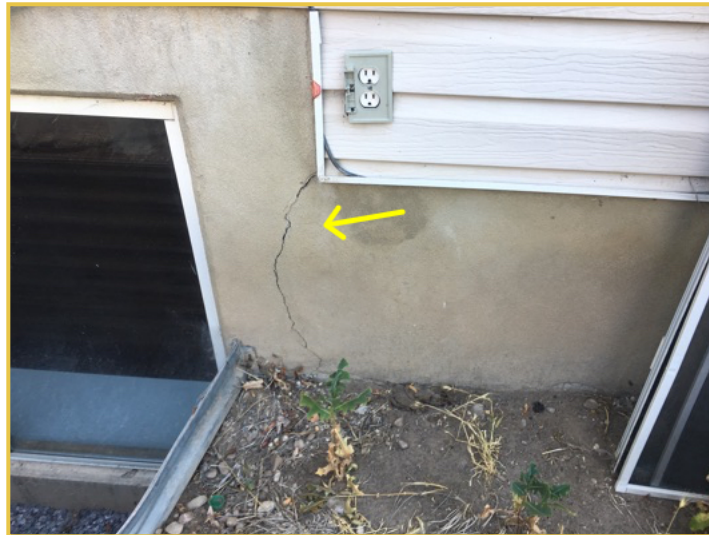
- **Foundation had a large crack. Recommend evaluation and repair by a foundation contractor.**

Large Foundation Crack

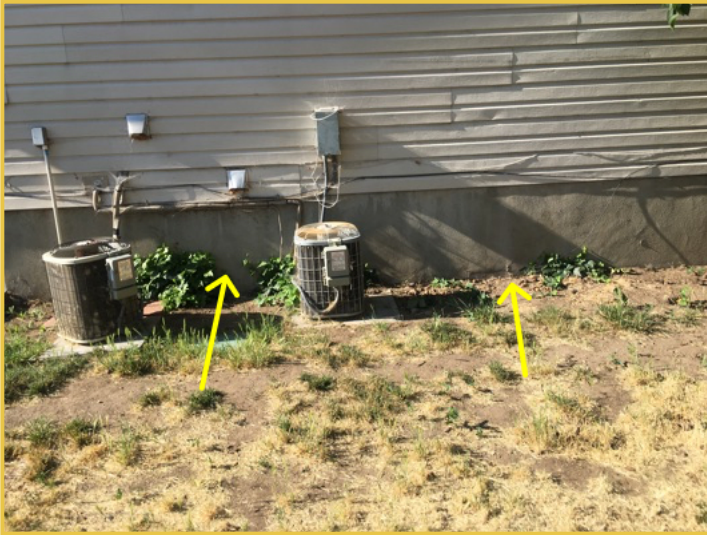
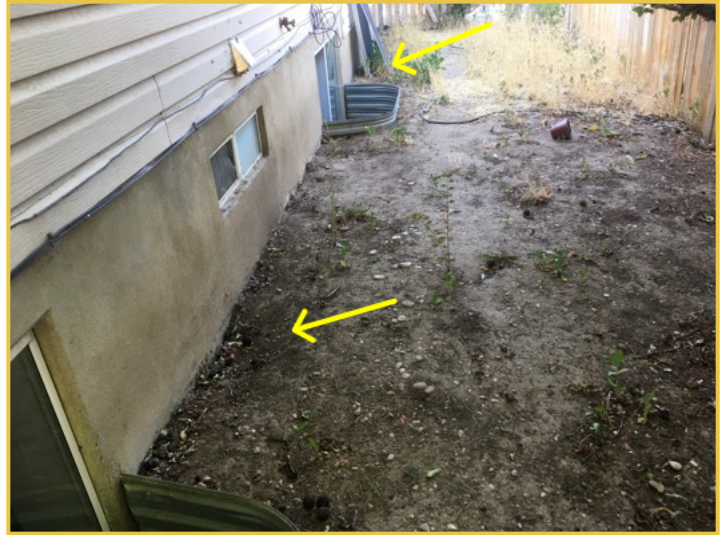
- **Grading was improperly sloped towards the foundation. Recommend adding dirt to properly slope the grading away from the house to prevent moisture intrusion.**
- **Grading at the window well was too low. This may allow continuous erosion until the water gets below the foundation. Recommend filling the well until it is 4-6 inches below the window sill.**

Improperly Sloped Grading

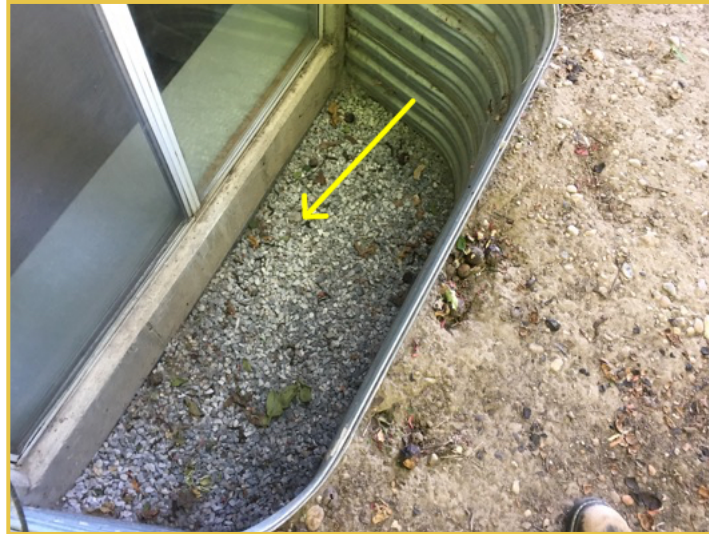
Window Well Grading Too Low

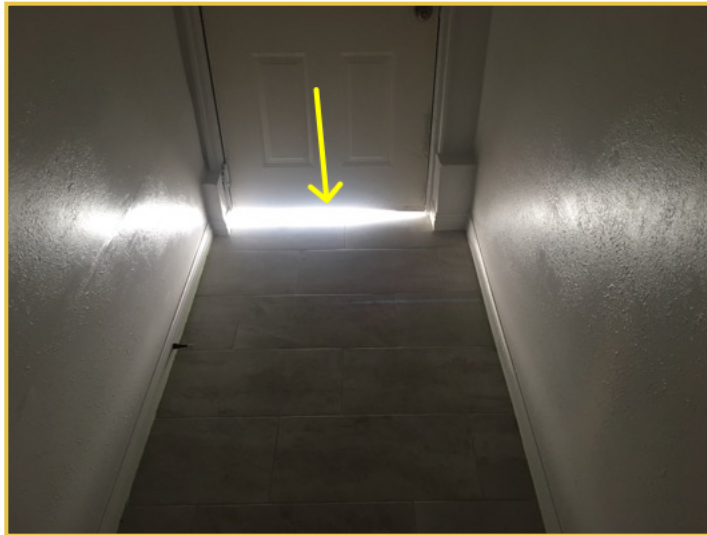
- Exterior door/trim had chipped, worn, or no paint/stain. Recommend keeping the door/trim painted/stained to prevent damage.
- Exterior door had missing, loose, or damaged weatherstripping. Recommend repair.

Missing Exterior Door Weatherstripping

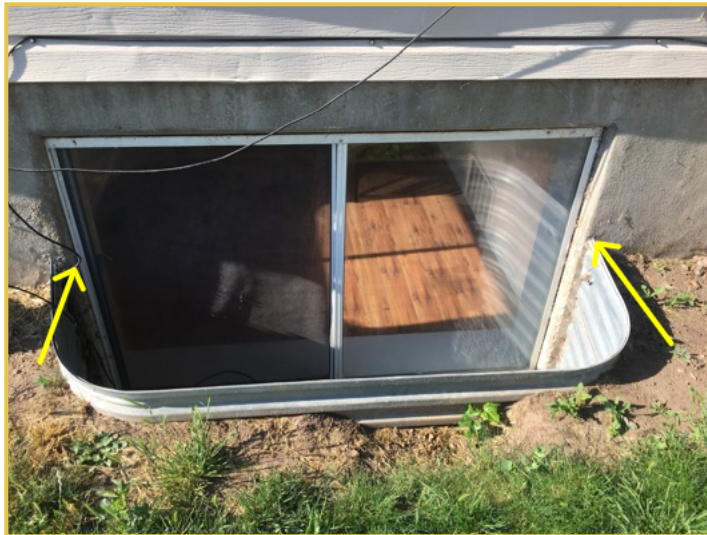
- Exterior windows had a missing/damaged screen. Recommend repair.
- Exterior windows had cracks that needed caulking. Recommend repair to prevent water from getting into the cracks. There may be hidden damage if water has gotten behind the window. Recommend sealing.

Basement Window Caulking Needed

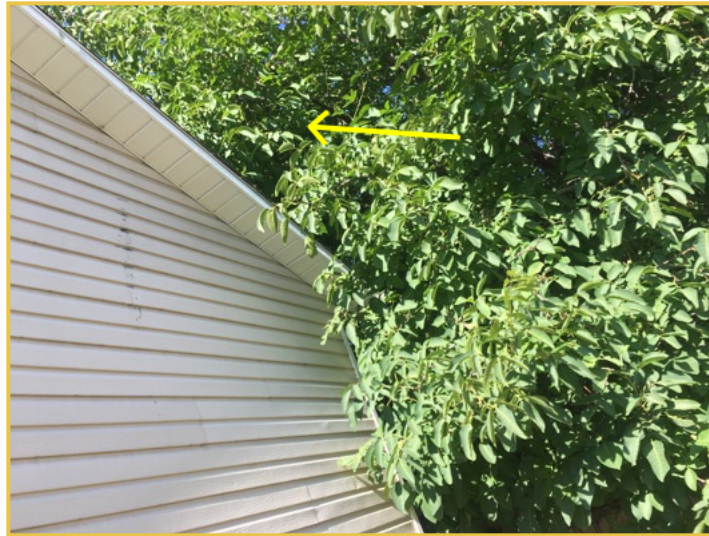
- Tree limbs/branches were touching the house or roof. Recommend repair.

Tree Branches in Contact with the Roof

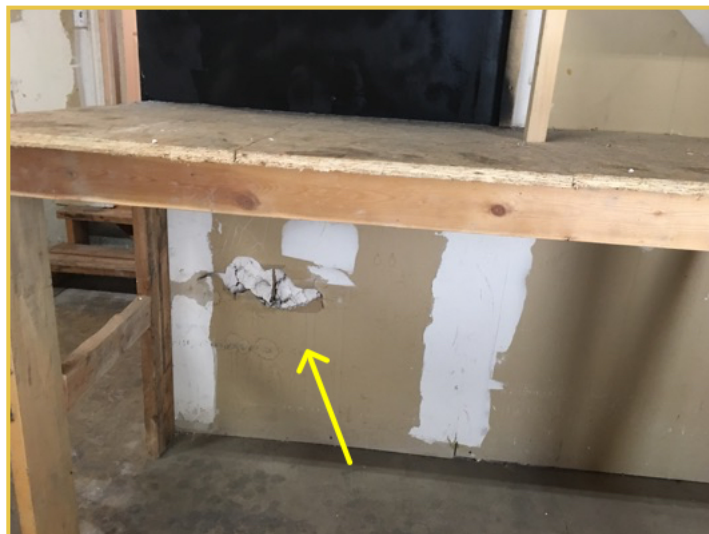
- Garage wall/ceiling had damage/holes or missing/loose drywall mud/tape. Recommend repair to maintain fire separation between the garage and living space/attic.

Holes in the Garage Wall

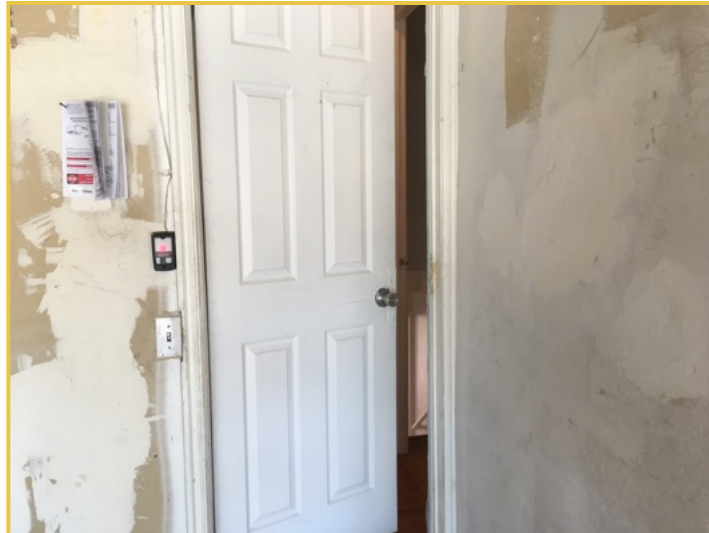
- Door between the garage and house did not appear to be a fire-rated door. Recommend replacing with the appropriate door.

Garage Door Not Fire Rated

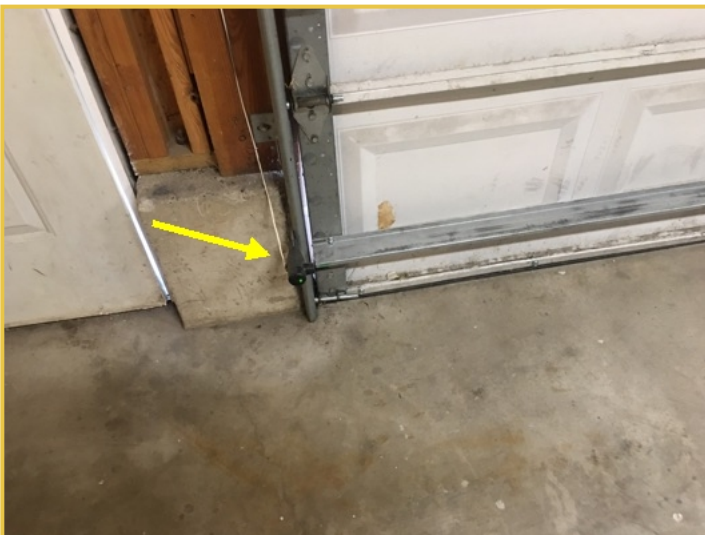
Garage Door Reverse Sensors Too High

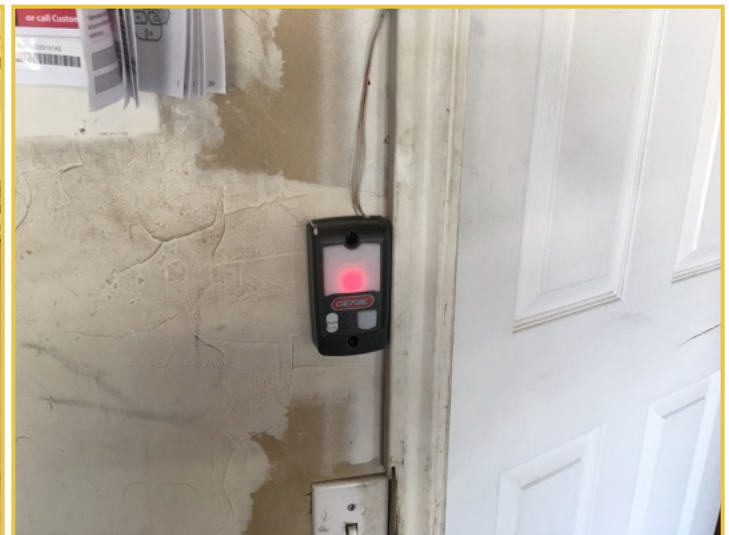
Garage Opener Button Too Low

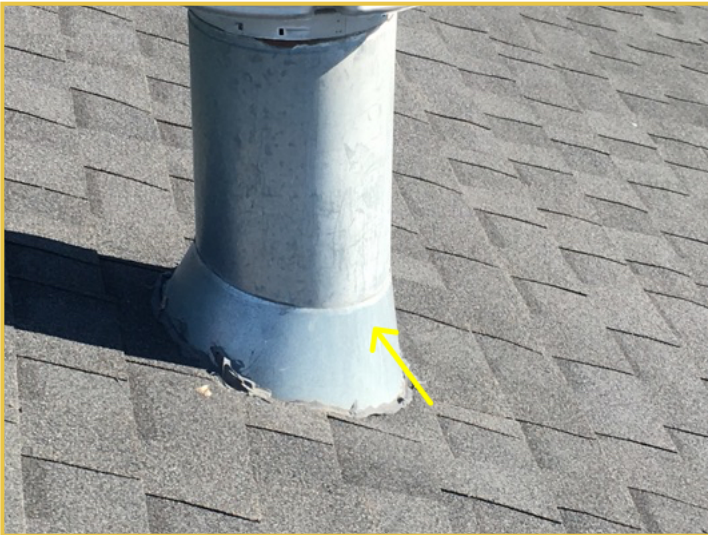
Gap in the Vent

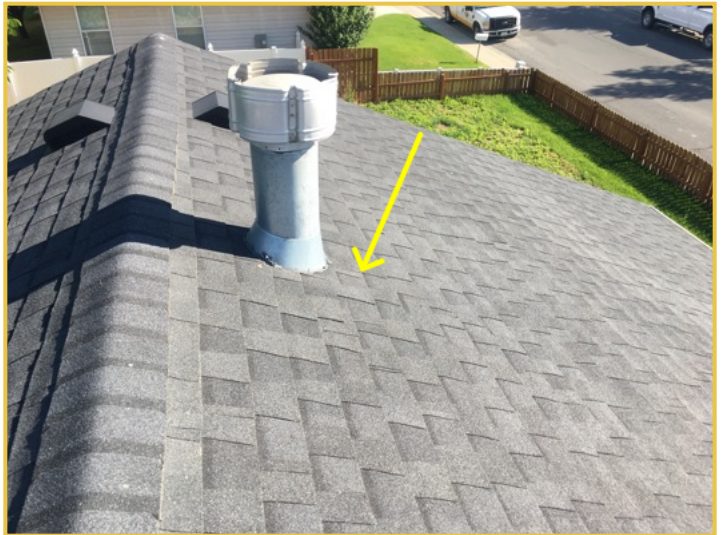
- Vent/flushing had a gap. Recommend repair or replacement to prevent water intrusion.
- Vent flashing was not installed properly. Recommend repair to prevent water intrusion.

Improper Vent Flashing Installation

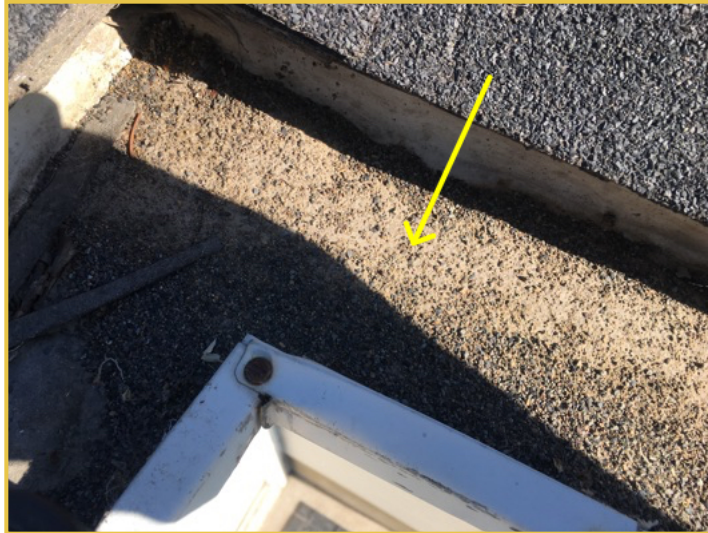
- Rain gutters had debris. Recommend cleaning.
- Rain gutter was damaged. Recommend repair.

Debris in the Rain Gutters

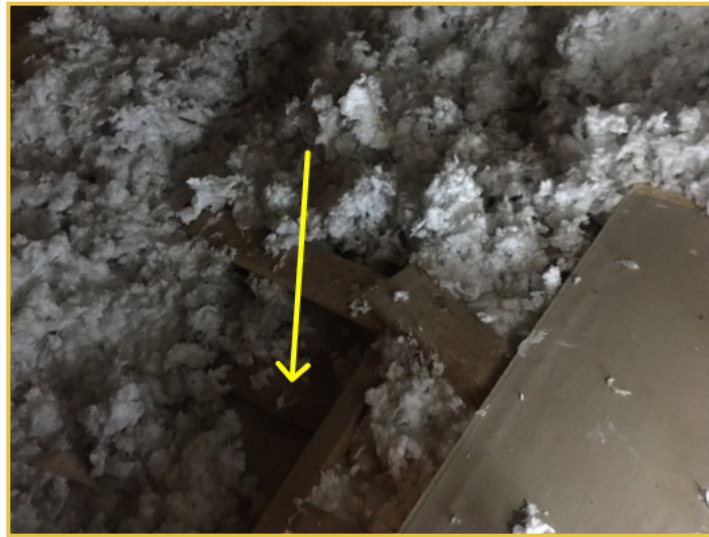
- Attic insulation was missing or low. Recommend adding insulation to these areas.

Areas of Missing Insulation

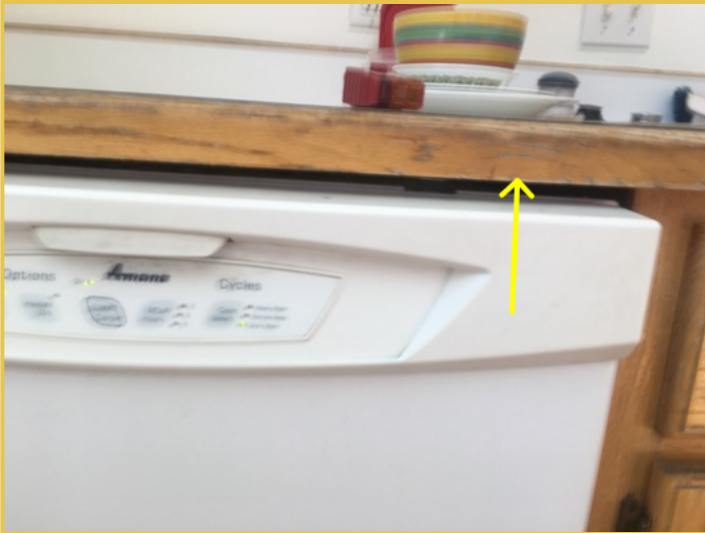
- Dishwasher had mineral buildup/debris. Recommend cleaning.
- Dishwasher was not fastened to the counter top or cabinet. It could tip if weight is placed on the open door or leak if it is not correctly leveled. Recommend repair.
- Dishwasher made an unusual noise that indicated that it may not be operating properly. Recommend repair.

Main Floor Dishwasher Not Secured to the Counter Top or Cabinets

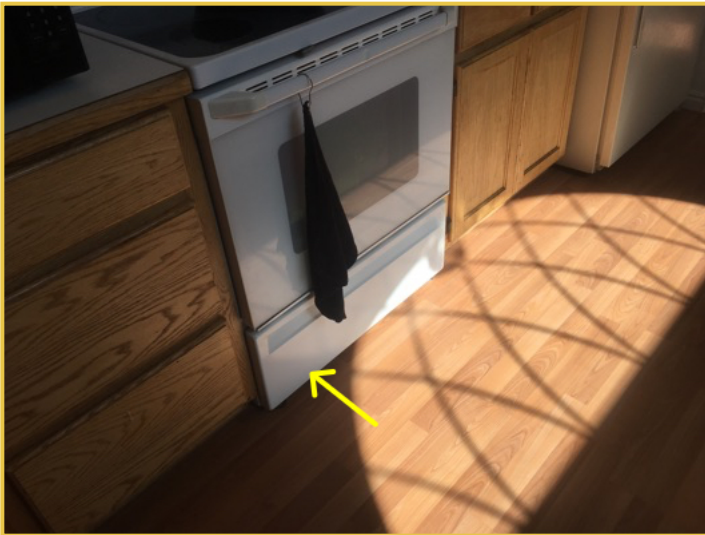
- Oven was dirty. Recommend cleaning, especially if there is a lot of food built up, to prevent an oven fire.
- Stove was not fastened to the floor with an anti-tip bracket. A child climbing onto an open oven door could overturn the range. Recommend installing.

No Main Floor Oven Anti-Tip Bracket

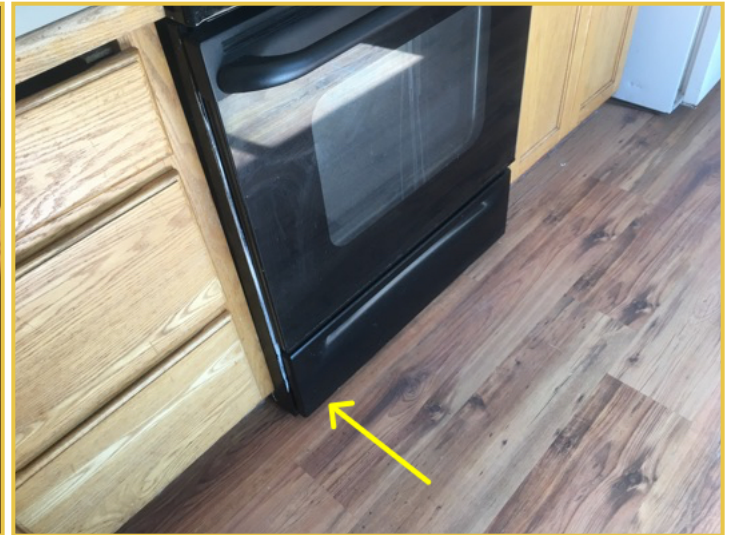
No Basement Oven Anti-Tip Bracket

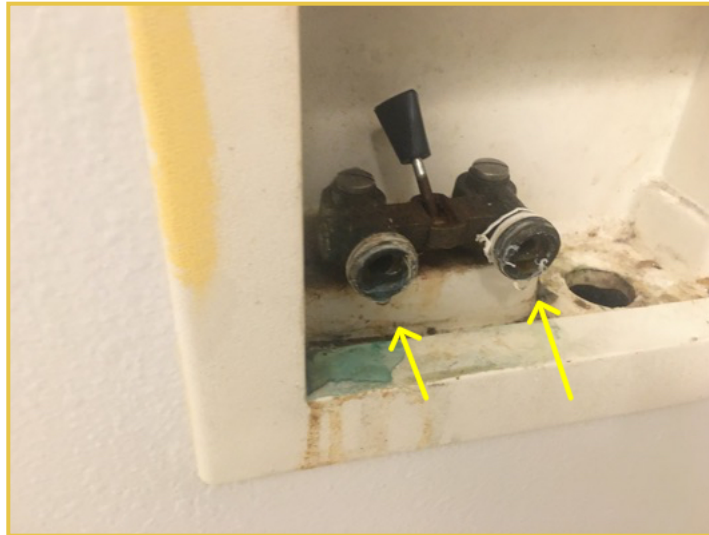
- No drain pan present under the washing machine. Recommend installing to direct any water into the drain from a possible washing machine leak.
- Washing machine water line dripped/leaked. Recommend repair.

Basement Washer Water Line Dripped/Leaked

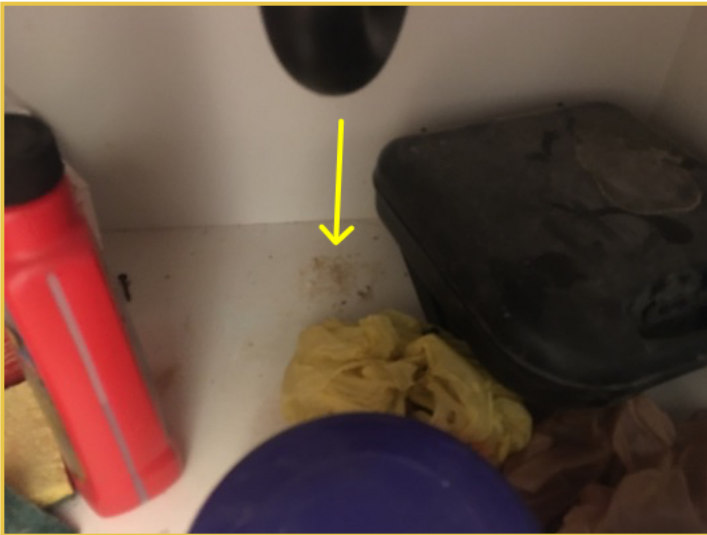
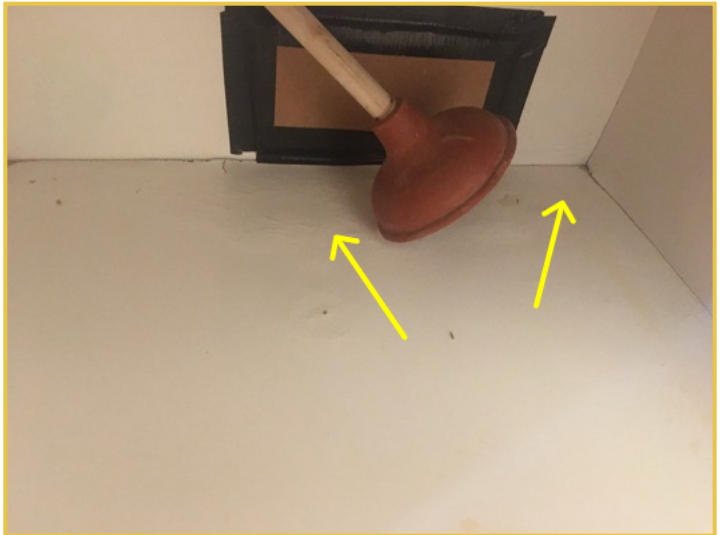
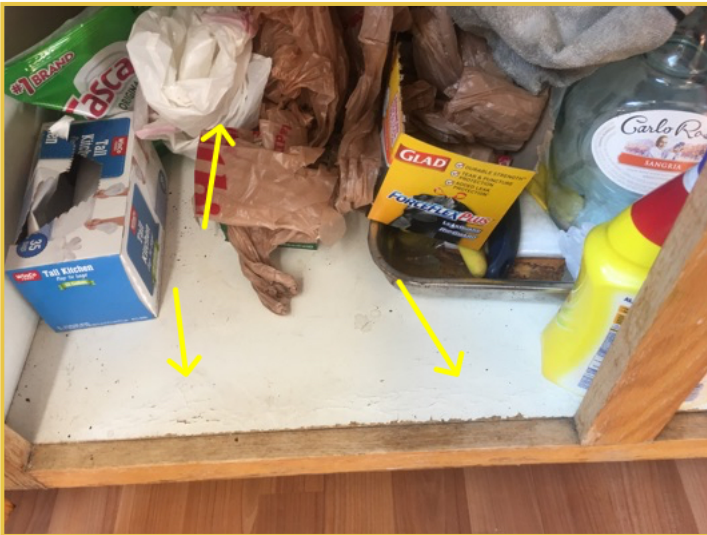
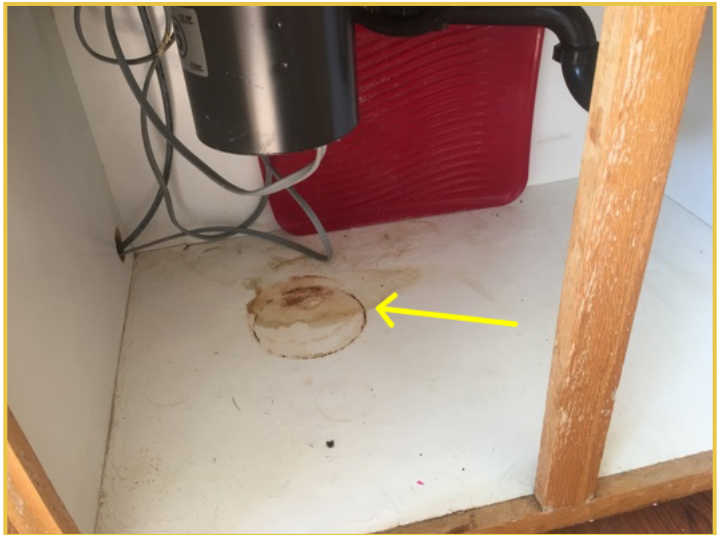
- **Cabinet had wear, damage, loose hardware, or missing hardware.**
- **Cabinet had evidence of past leaking. Tested dry at the time of the inspection. There may be hidden damage that requires a more invasive inspection that cannot be found during a normal home inspection. Recommend monitoring for future leaks, having the item further evaluated, and having any issues repaired by a qualified contractor as needed. You may also refer to the seller's disclosures or ask the seller for more information.**

Evidence of Past Leaking at the Main Floor Hall Bathroom Sink Under Cabinet

Evidence of Past Leaking at the Basement Bathroom Sink Under Cabinet

Evidence of Past Leaking at the Main Floor Kitchen Sink Under Cabinet

Evidence of Past Leaking at the Basement Kitchen Sink Under Cabinet

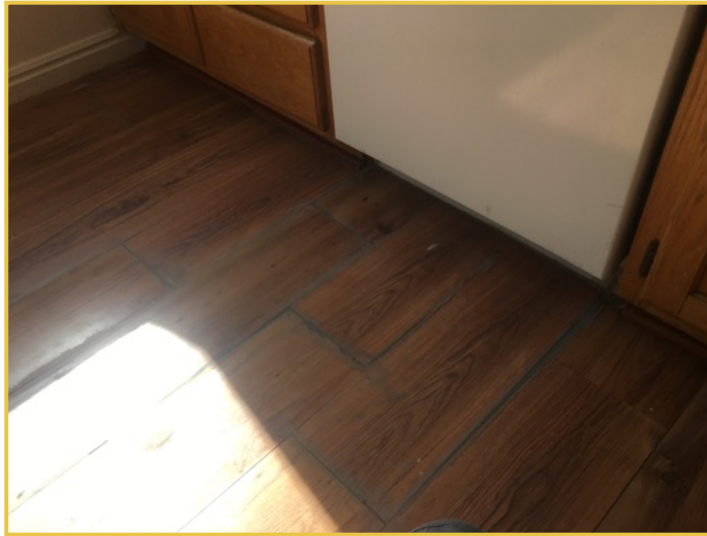
Evidence of Past Leaking on the Basement Kitchen Floor That Was Dry

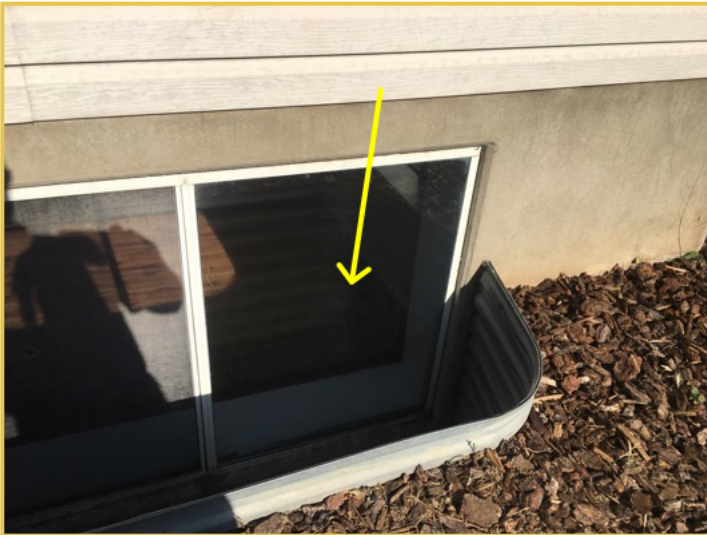
- Interior window seals were broken or loose. Windows had moisture in between the panes. This obscures the window and reduces energy efficiency. Recommend replacement.

Condensation In the Basement East Window

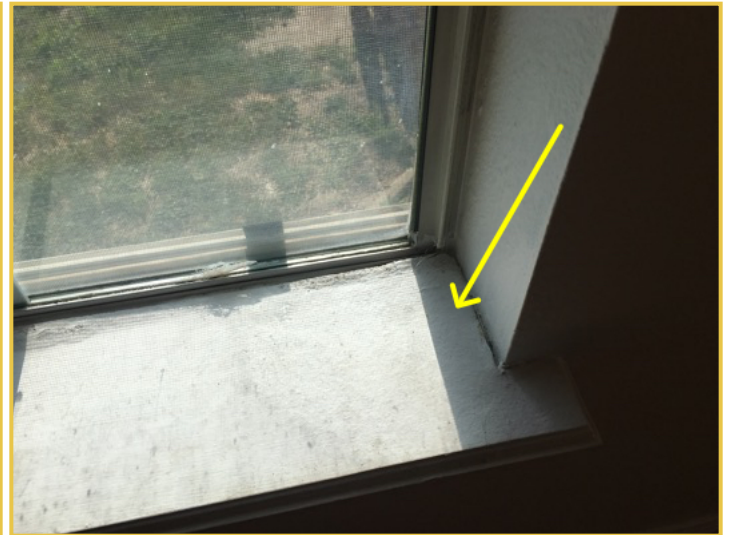
- Interior windows/sills had evidence of past leaking. Tested dry at the time of the inspection. There may be hidden damage that requires a more invasive inspection that cannot be found during a normal home inspection. Recommend monitoring for future leaks, having the item further evaluated, and having any issues repaired by a qualified contractor as needed. You may also refer to the seller's disclosures or ask the seller for more information.

Evidence of Past Leaking at Several Window Sills That Was Dry

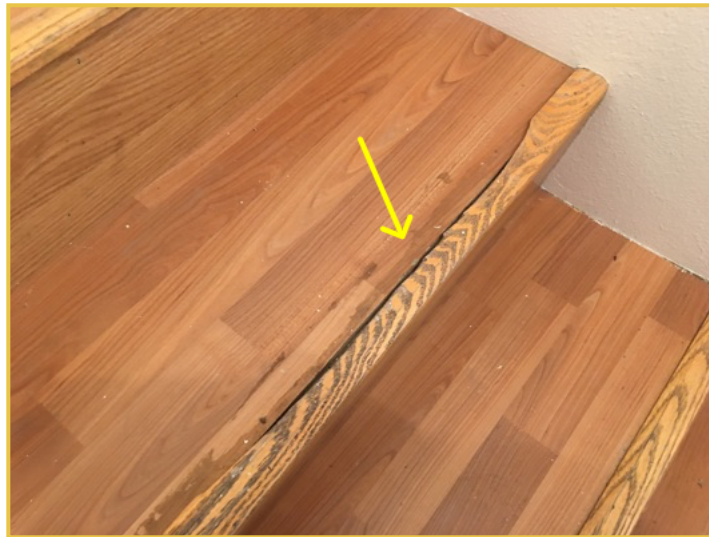
- Stairs were loose/damaged. Recommend repair.

Damaged Stair Nosings

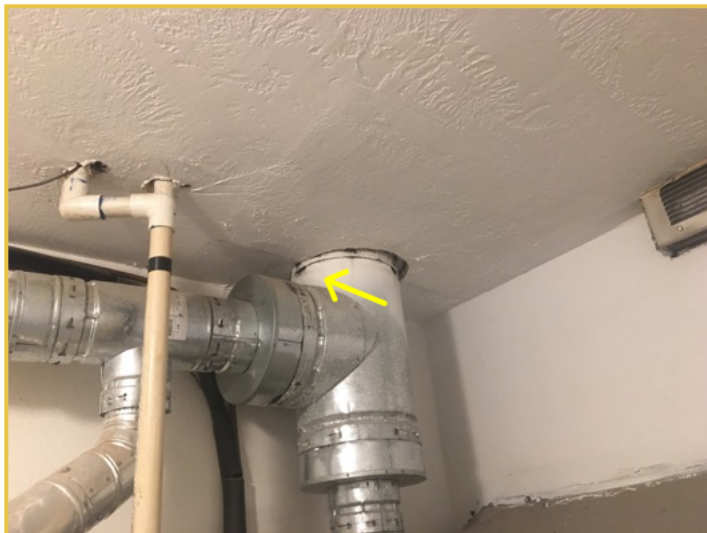
- Heater exhaust piping should not be in contact with any combustible materials. A gap of at least 1 inch should be maintained to prevent melting/fire. Recommend repair.

Basement Hot Heater Exhaust Piping In Contact With Combustible Material

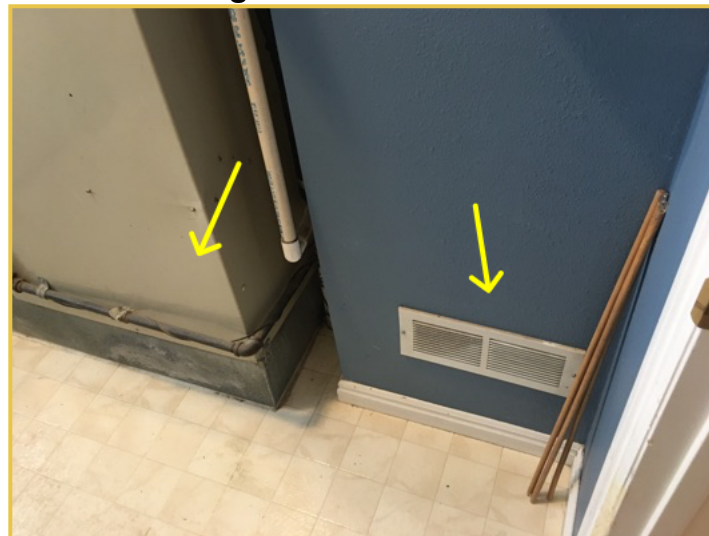
- Return air grill had accumulated dust. Recommend cleaning.
- Return air vent was located too close to the heater or combustion appliance. Recommend moving the return air so that it is more than 10 feet away from the appliance.

Return Air Within 10 Feet of the Heater

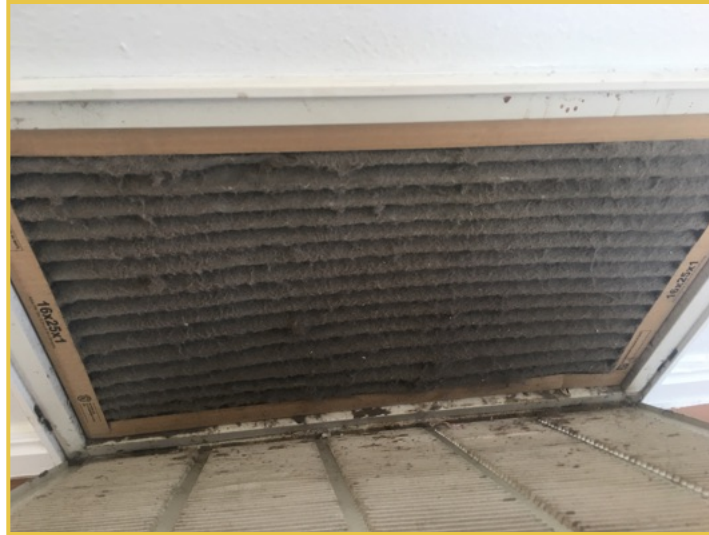
- MAINTENANCE: The air filter should be inspected at least monthly and replaced as needed when dirty. Remember that dirty filters are the most common cause of inadequate heating or cooling performance. Recommend replacing the filter the day you move in and keeping a schedule for replacement.
- Air filter was dirty. Recommend replacement.

Dirty Air Handler Filter

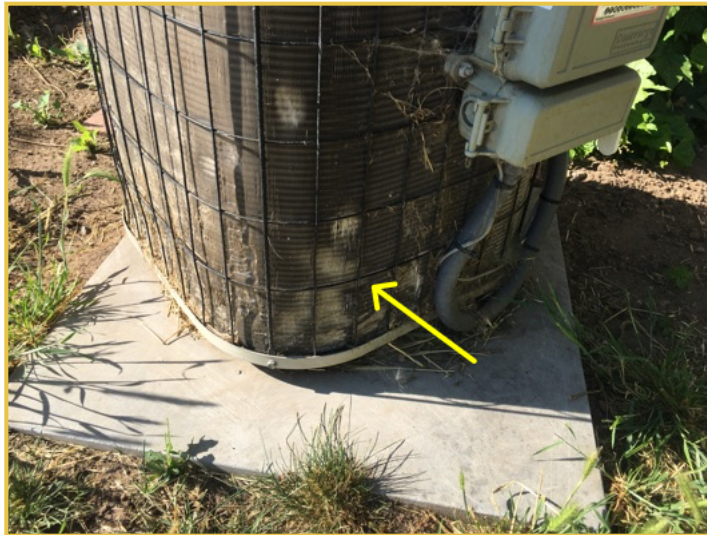
- **Air conditioning condenser had dirt/debris around it. Recommend clearing.**
- **Air conditioning units have an estimate lifespan of 8-20 years. It is recommended that the air conditioning be evaluated by a qualified HVAC technician to determine if any repairs are needed, give a more accurate remaining life, and determine if replacement of any components are needed with an accompanied bid for replacement. A full and complete air conditioning evaluation goes beyond the home inspection standards of practice and the home inspector does not perform such an evaluation. Planning and budgeting for replacement should be considered.**
- **Air conditioning condenser fins were damaged. This restricts air flow and causes the unit to run ineffectively. Recommend possible repair or, if damage is significant, exploring options for replacement.**

Air Conditioner Condensers Fin Damage

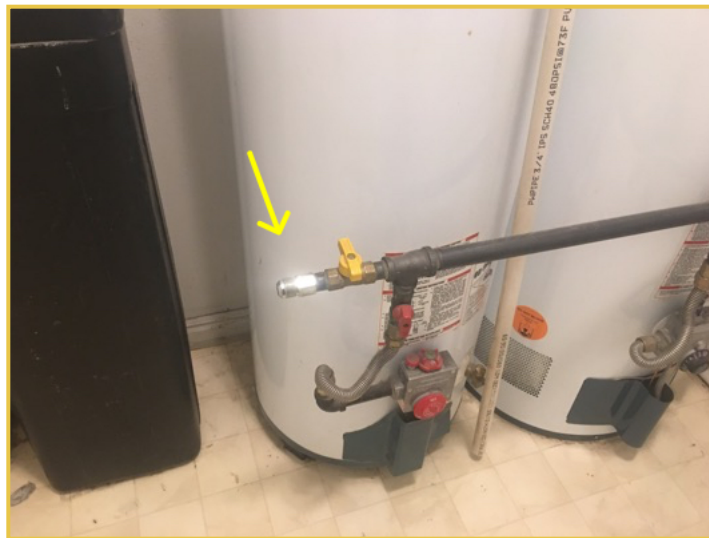
- Gas piping did not have a drip leg. The purpose of a drip leg is to prevent particulates or moisture from condensation from entering and clogging the appliance gas valve, which can cause the appliance to shut down. Recommend adding drip legs where needed.
- Gas piping did not have a cap or appliance attached. Recommend capping the gas line if not in use.

Utility Room Gas Line Should be Attached to an Appliance or Capped

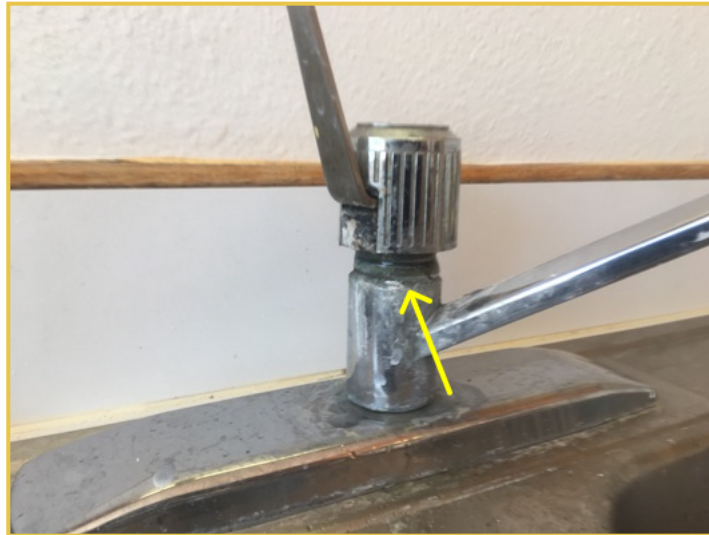
- Sink faucet drain stoppers were missing or did not function properly. Recommend repair.
- Sink faucet or side sprayers dripped/leaked. Recommend repair or replacement.

Kitchen Sink Faucet Dripped/Leaked

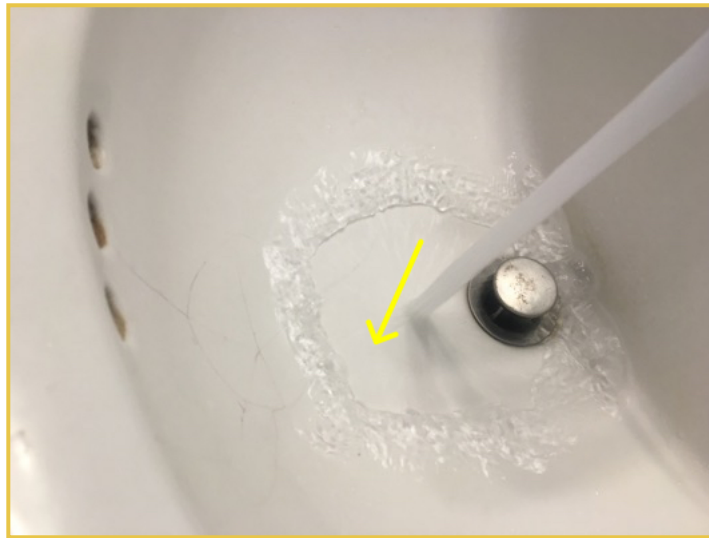
- Sink was cracked. Recommend repair or replacement.

Cracked Main Floor Hall Bathroom Sink

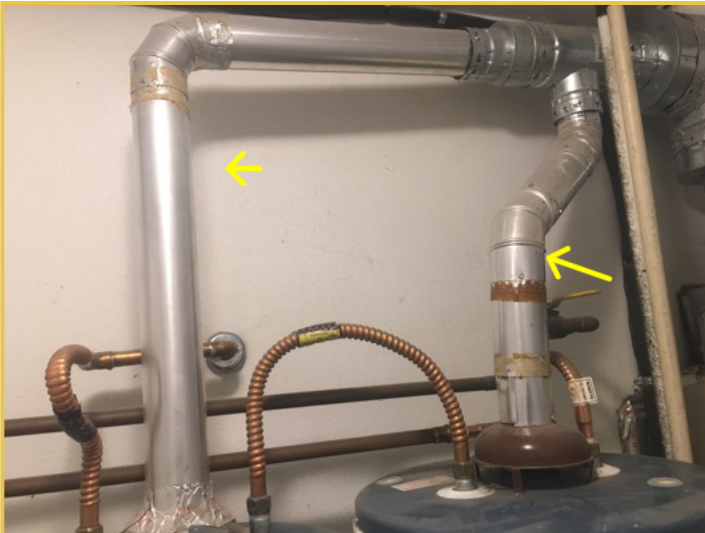
- Water heater exhaust piping was under sized. The current size may have been acceptable when the water heater was installed. Current installations have a 4-inch exhaust. Recommend installing a larger exhaust to vent more efficiently.
- Water heater exhaust pipe connection to the furnace exhaust pipe should be a "WYE" and not a "T" type connection. Recommend repair.

Water Heater Exhaust Pipe Too Small in Diameter - Less Than 4 Inches

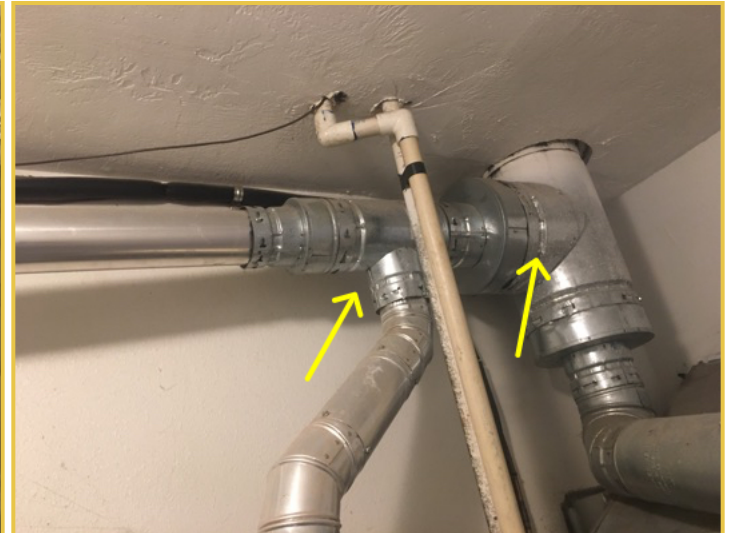
Improper Water Heater Exhaust Pipe Connection

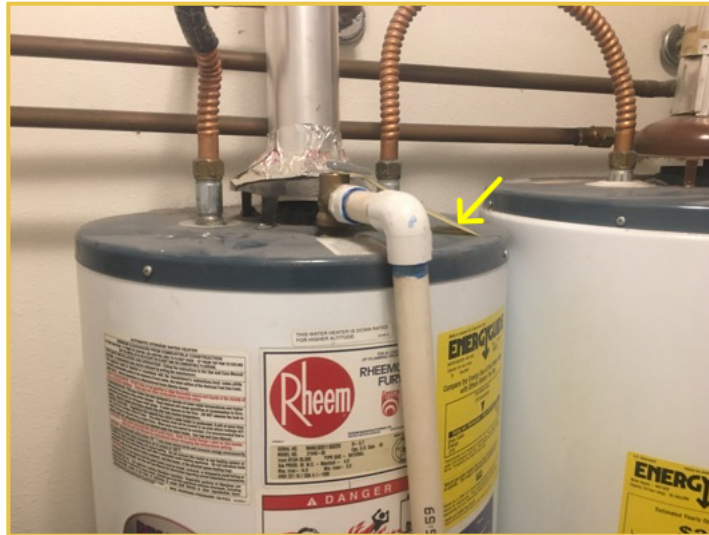
- Water heater temperature pressure relief (TPR) valve pipe should be a high heat tolerance pipe (ie, copper NOT **PVC**). Recommend replacement.

TPR Valve Pipe Not High Heat Tolerant

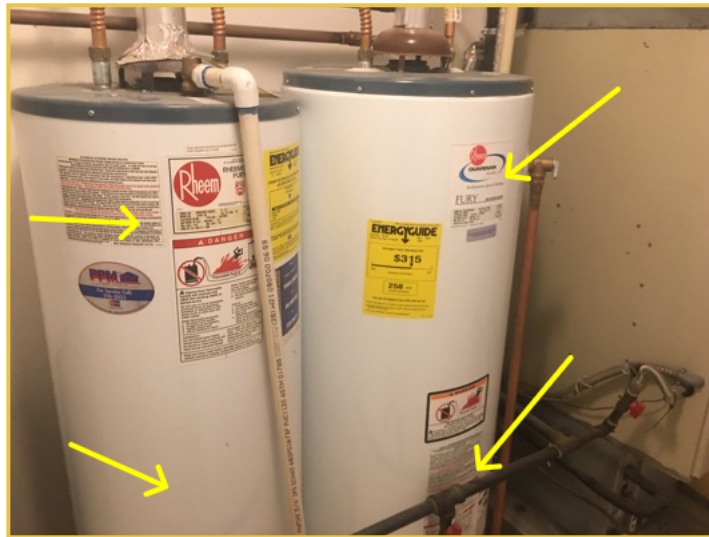
- Water heater did not have earthquake strapping. Recommend installing to secure the water heater.

No Water Heater Earthquake Strapping

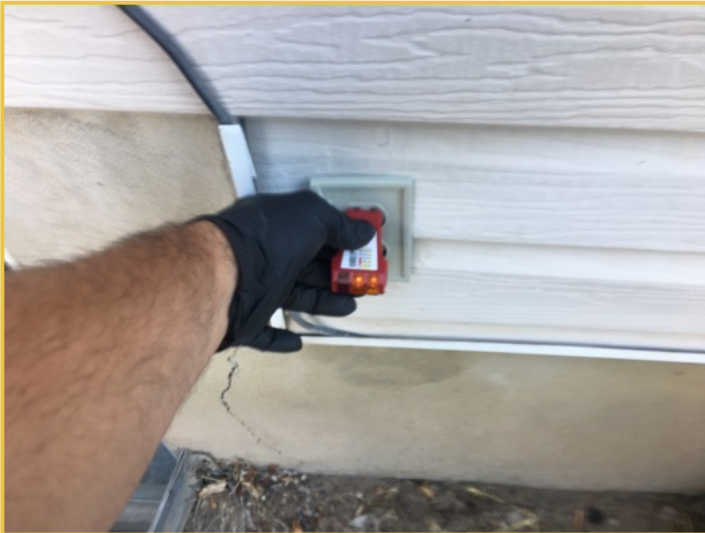
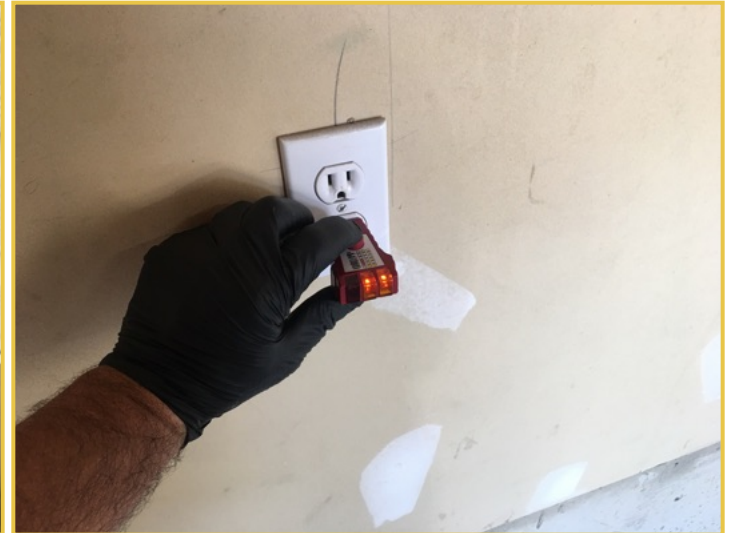
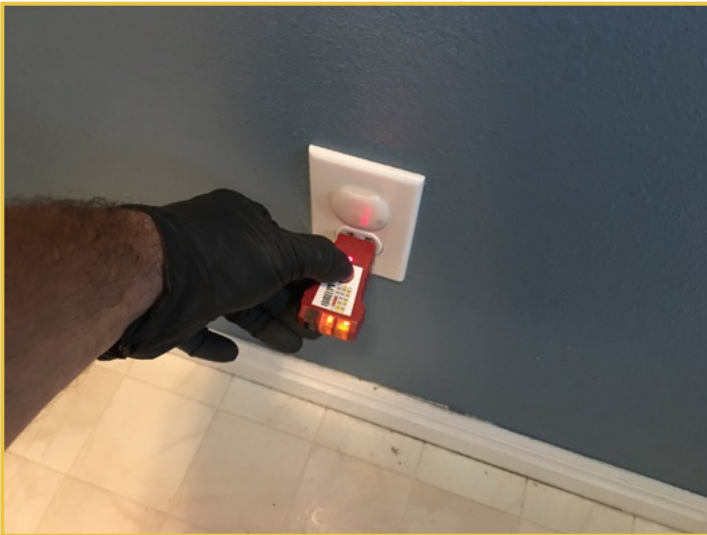
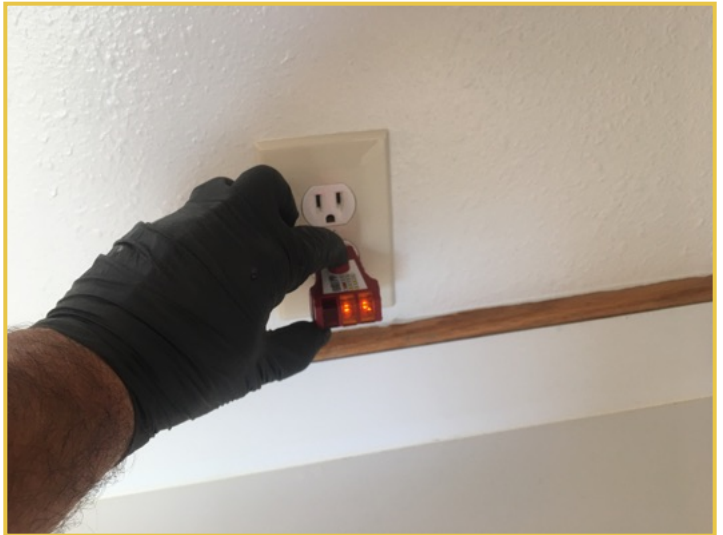
- Outlet was not **GFCI** protected. Recommend having GFCI outlets installed by a qualified contractor. GFCI outlets are required at the exterior (as of 1973), bathrooms (as of 1975), garage (as of 1978), kitchen within 6 feet of the sink (as of 1987), at all kitchen counter tops (not just within 6 feet of the sink - as of 1996), near utility, garage, or laundry sinks (as of 2005), and at all laundry areas (as of 2014).

Exterior Outlets Not GFCI Protected

Garage Outlets Not GFCI Protected

Laundry Outlets Not GFCI Protected

Basement Kitchen Outlets Not GFCI Protected

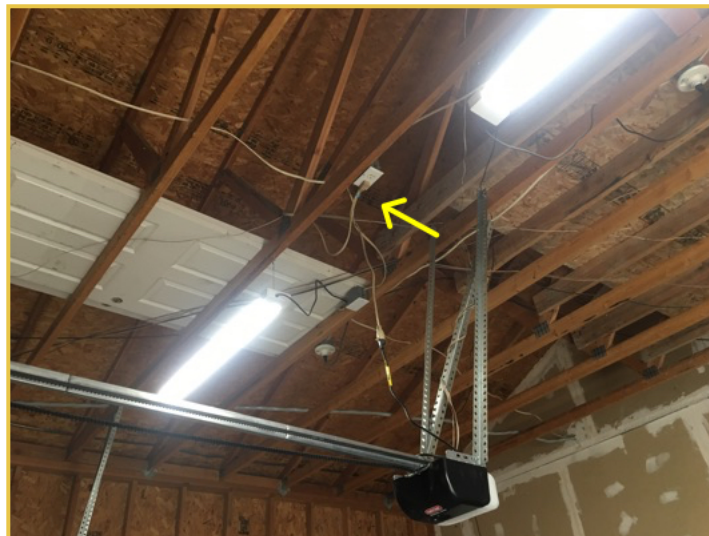
- Extension cord was being used improperly in a permanent installation (garage opener, appliance, bring power elsewhere, etc.) or was routed through a wall, floor, or ceiling. Recommend repair.

Improper Use of Extension Cord at the Garage Door Opener

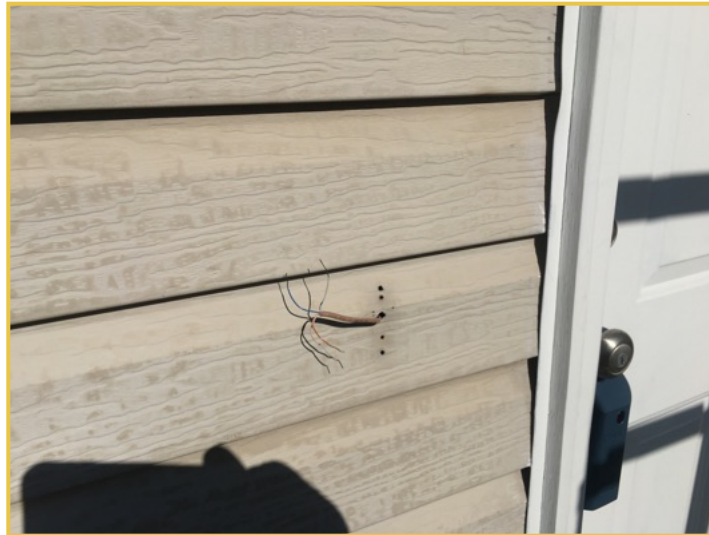
- Doorbell components was broken/missing. Recommend repair.

Missing Doorbell Components

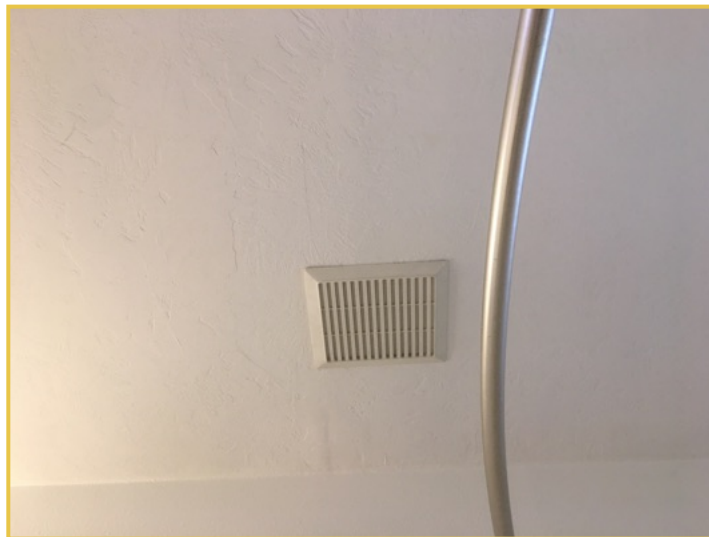
- Exhaust fan did not function. Recommend repair or replacement.

Main Floor Hall Bathroom Exhaust Fan Did Not Function

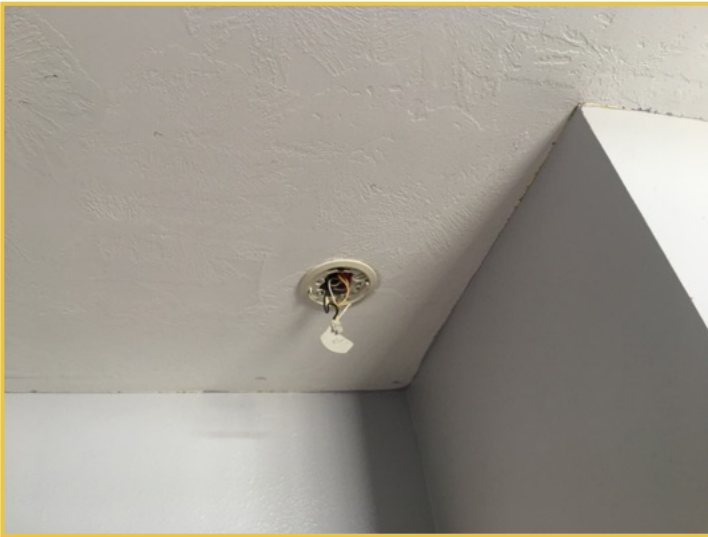
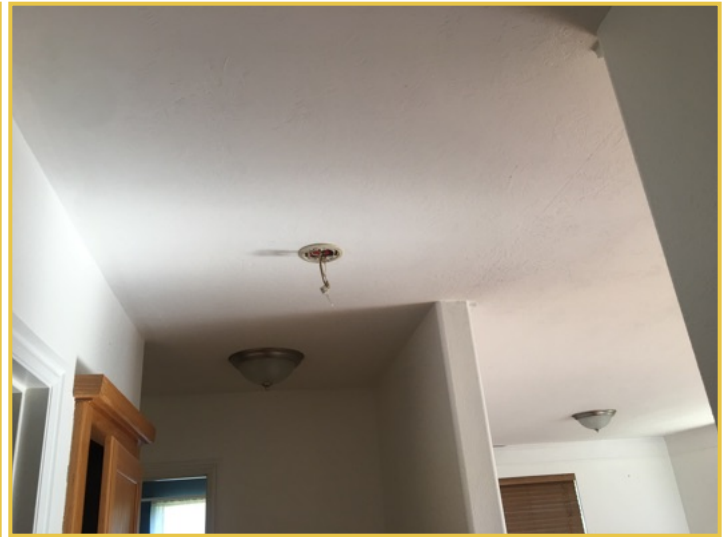
- Smoke/carbon monoxide detector was not installed where it should be or was missing. Recommend ensuring that one smoke detector is installed in each bedroom, one smoke/carbon monoxide detector is installed in each hallway, and one smoke/carbon monoxide detector is installed in or near the utility room for safety.

Missing Smoke Detectors

No Hallway Smoke/Carbon Monoxide Detector

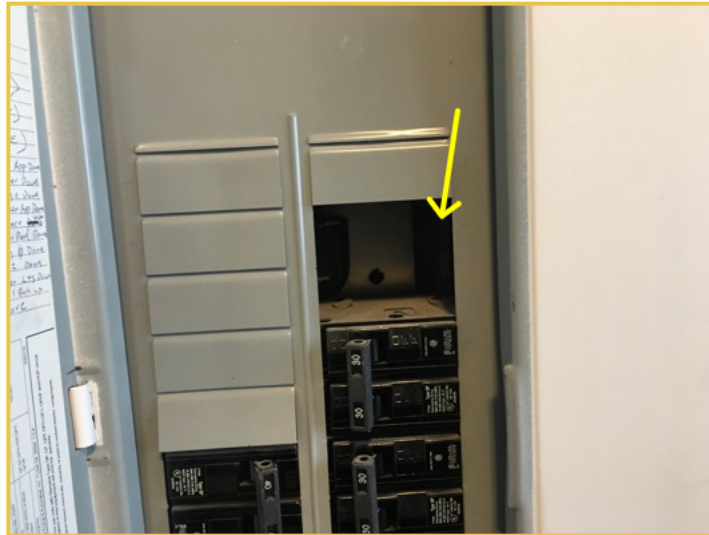
- **Electrical panel cover screws were missing. Recommend installing.**
- **Electrical panel had missing breaker knockouts. Recommend covering for safety.**

Missing Breaker Knockout

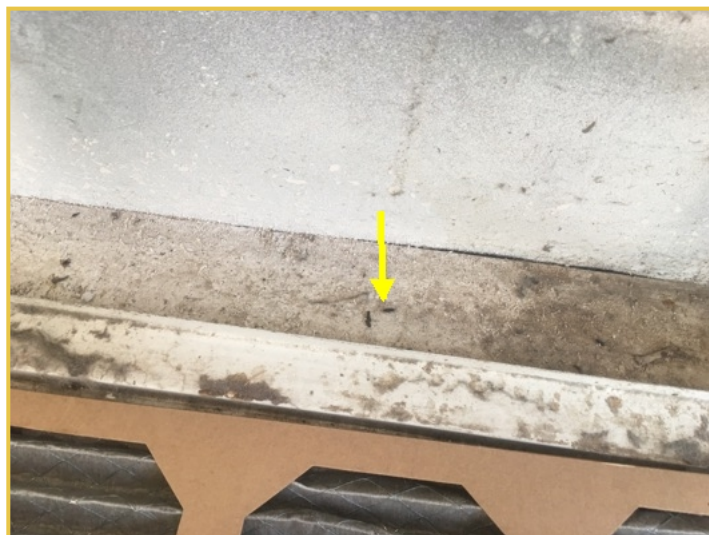
- House had evidence of rodents. Recommend inspection and treatment by a pest control company.

Rodent Droppings in the Basement HVAC Return
