INSPECTION REPORT

123 West 456 South
Provo, Utah 84604
Prepared For: John Doe
Date: 4/9/2020 Time: 9:00 AM

Inspector: Mike Thomson
NACHI16060803

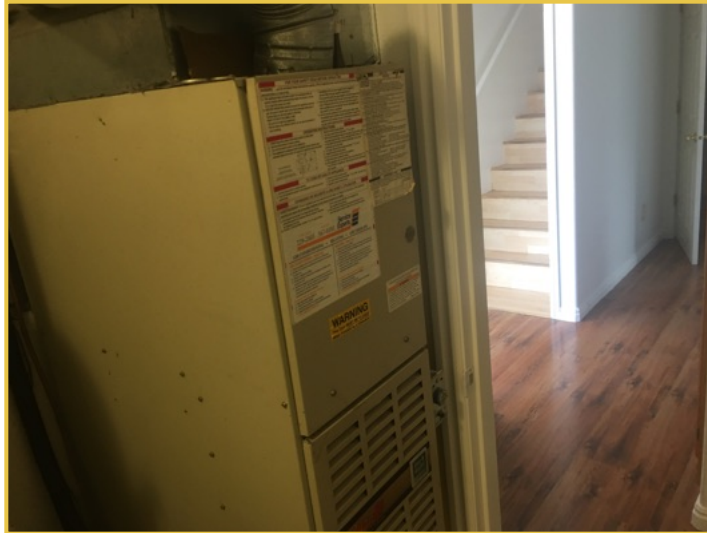
- Heater did not have a green sticker. A green sticker is an adhesive sticker placed on your heater by a licensed heating contractor. The green sticker verifies that the heater has been properly adjusted to safely burn natural gas at your altitude. If your heater is not properly adjusted it may not operate safely. Recommend evaluation and adjustment as well as the placement of a green sticker on your heater.

No Green Sticker on the Basement Heater

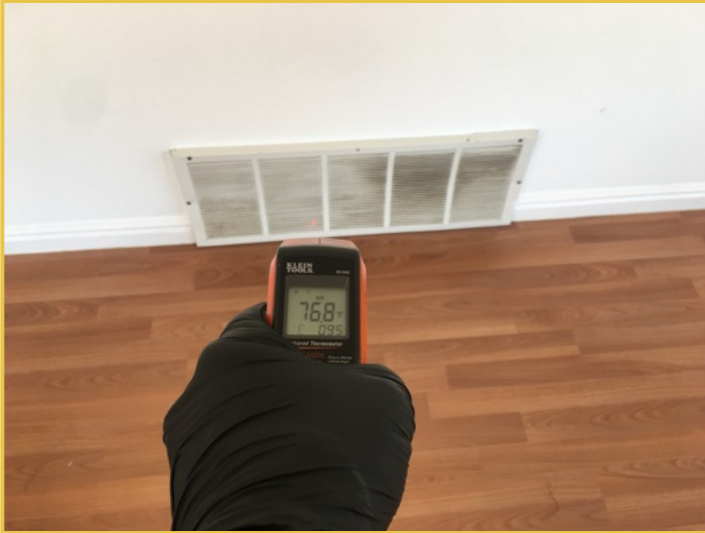
Main Floor Return Air Was at 76 Degrees

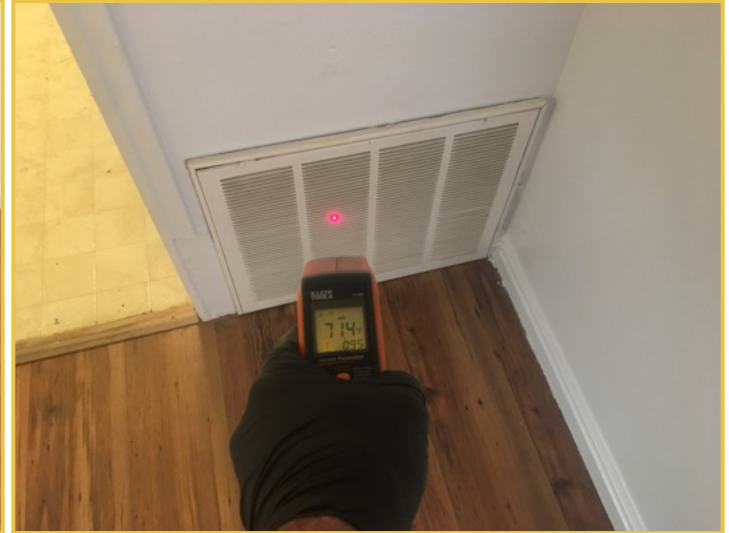
Basement Return Air Was at 71 Degrees

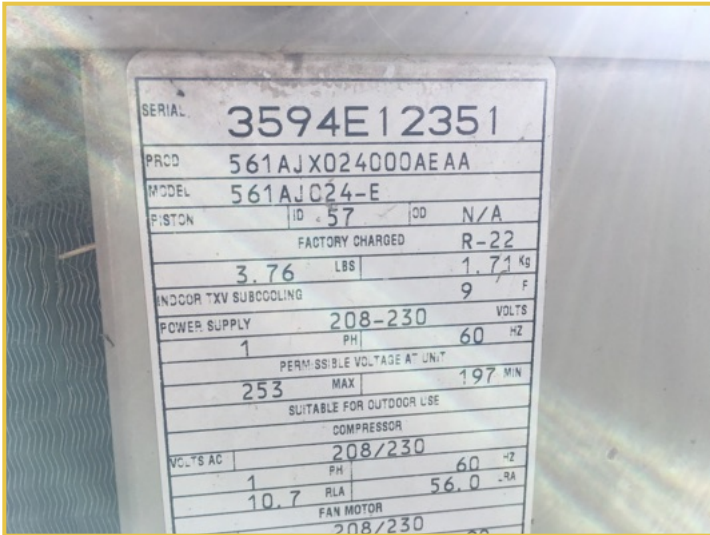
Main Floor Air Conditioning Condenser Dated September 1994

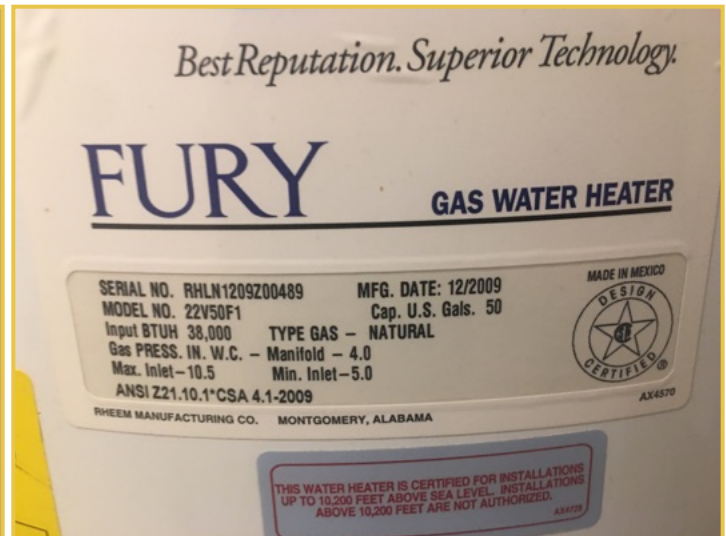
Water Heater Dated December 2009
