INSPECTION REPORT

123 West 456 South
Provo, Utah 84604
Prepared For: John Doe
Date: 4/9/2020 Time: 9:00 AM

Inspector: Mike Thomson
NACHI16060803

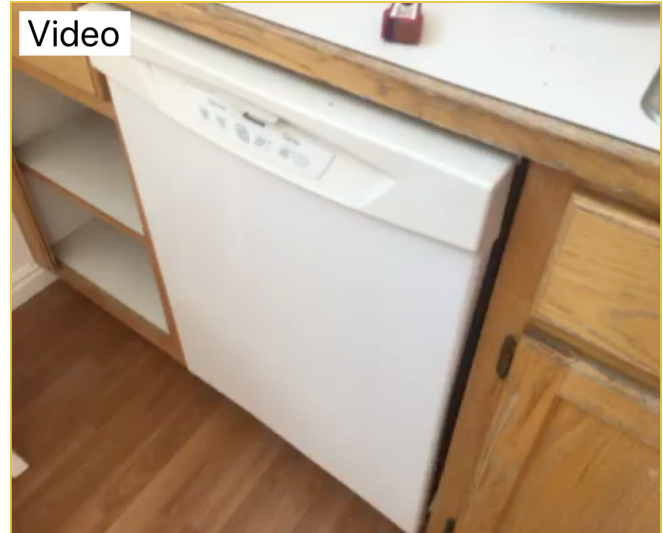
- Dishwasher had mineral buildup/debris. Recommend cleaning.
- Dishwasher was not fastened to the counter top or cabinet. It could tip if weight is placed on the open door or leak if it is not correctly leveled. Recommend repair.
- Dishwasher made an unusual noise that indicated that it may not be operating properly. Recommend repair.

Main Floor Noisy Dishwasher - CLICK TWICE IN ADOBE PDF TO PLAY

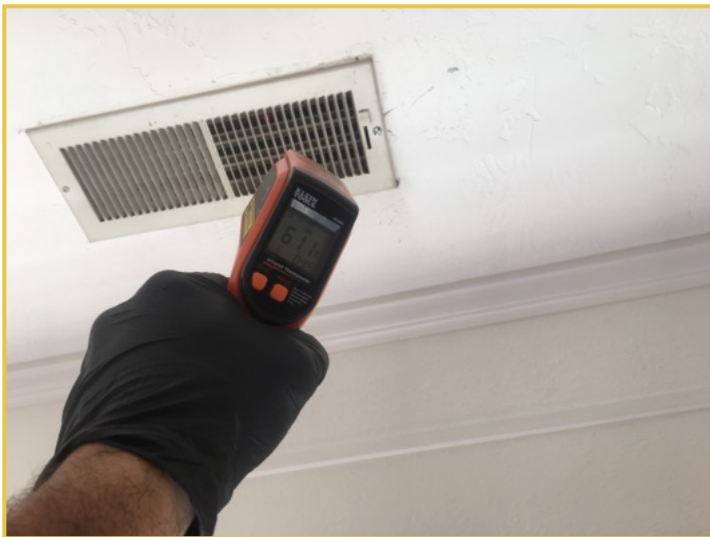
Main Floor Air Conditioning Ran at 61 Degrees
